Manhole Inspection Summary

Manhole # S03YY1015MH

Location Address: **3301 TANEY RD**

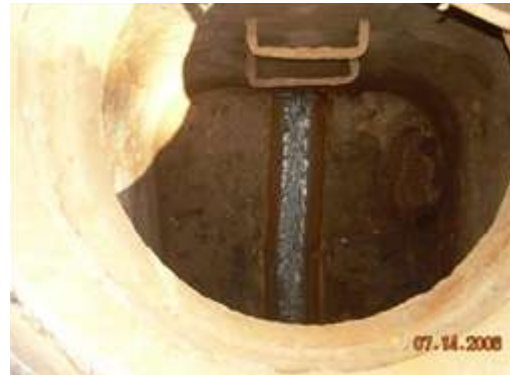
Top View

Frame leaks. Corbel and Barrel infiltration. Corroded steps. Evidence of surcharge - Bench debris.

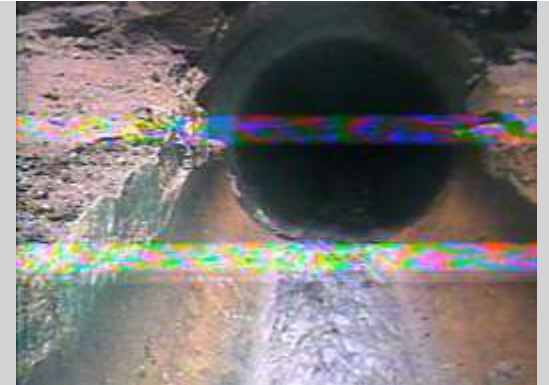
8 in. Circular Gravity Sewer Pipe Out @ 12 O'Clock

Infiltration: **None** Pipe Seal Cond: **Unknown**

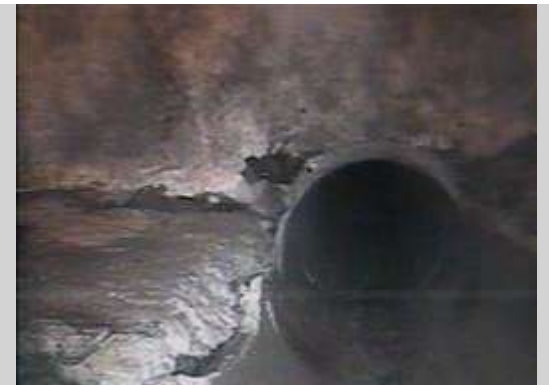
8 in. Circular Gravity Sewer Pipe In @ 6 O'Clock

Infiltration: **Evidence** Pipe Seal Cond: **Broken**
